HIGHWAY ACCIDENT REPORT

MULTIPLE VEHICLE COLLISION WITH FIRE DURING FOG
NEAR MILEPOST 118 ON INTERSTATE 40
MENIFEE, ARKANSAS, ON JANUARY 9, 1995

SPECIAL INVESTIGATION OF COLLISION WARNING TECHNOLOGY

**Adopted: December 4, 1995
Notation 6530A**

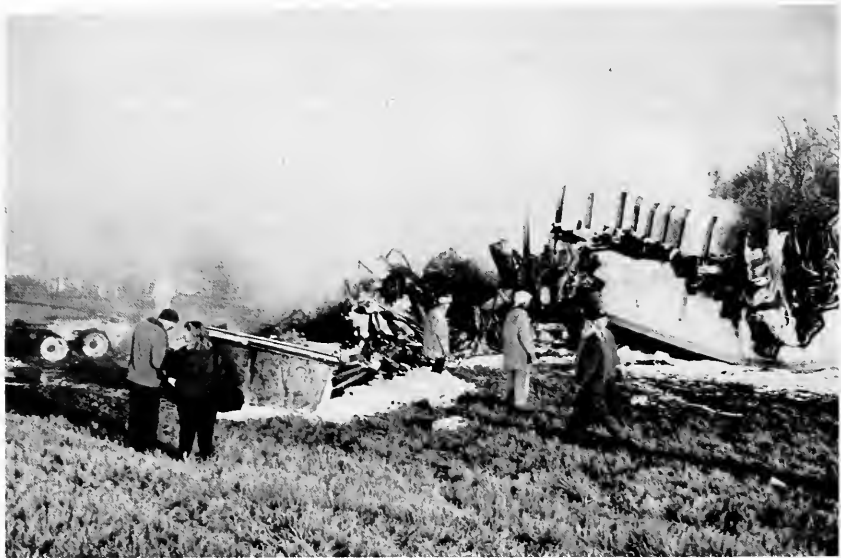
The rear of the fifth combination unit had heavy impact and fire damage. The sixth, seventh, and eighth combinations and the van were destroyed by impact and fire. (See figure 1.)

Figure 1. -- Remains of vehicles after impact and fire.

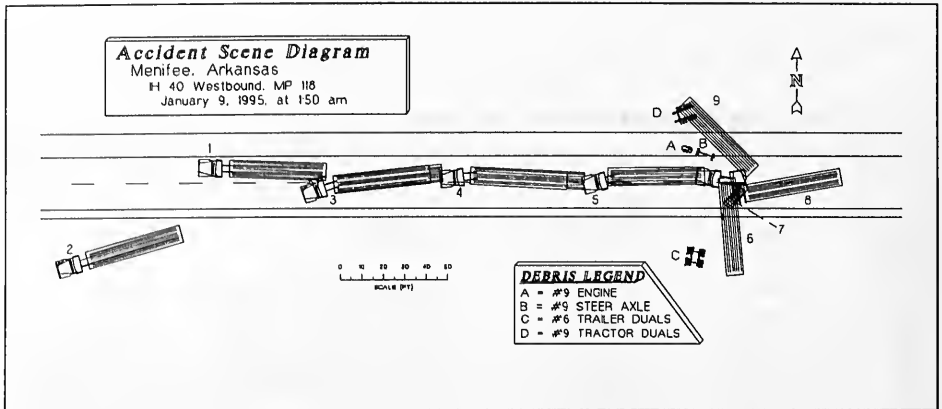
The collision sequence was initiated when an uninvolved cattle transporter and vehicle 1, traveling westbound, together slowed as the two vehicles entered an area of dense fog. Their drivers had been talking on the CB and had been warned over the radio about a dense patch of fog by truckdrivers traveling east on I-40. The driver of vehicle 1 reported that he had slowed from 65 miles per hour (mph) to between 35 and 40 mph. He stated that his vehicle was struck in the rear, damaging the axles and causing the loss of braking. He kept the vehicle straight in the right lane and continued to slow when his vehicle was struck again. He said that he "stayed in his truck for a couple of minutes and then the explosion behind him occurred after he exited his truck." (See figure 2.)

Figure 2. -- Postaccident scene diagram showing position of vehicles.

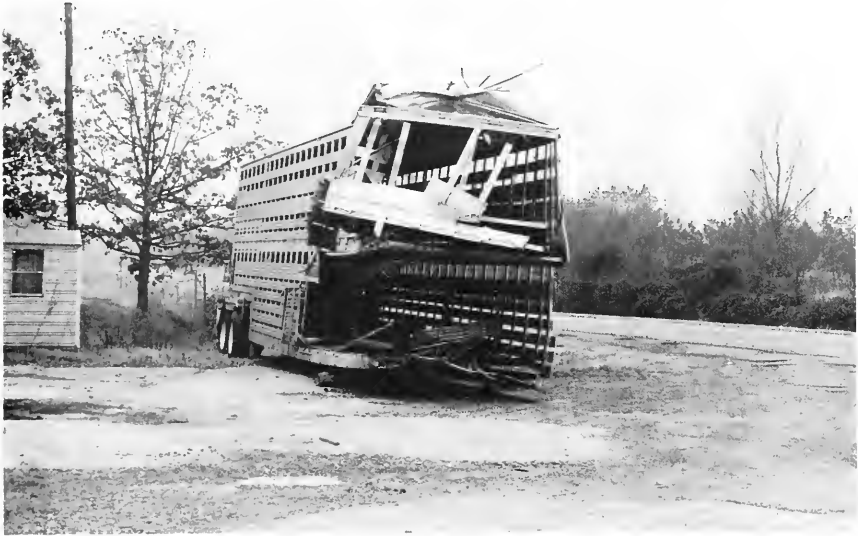
Vehicle 1 -- Vehicle 1 was a 1995 Peterbilt tractor in combination with a 50-foot, split level Barrett livestock semitrailer that was loaded with cattle. The combination weighed approximately 78,000 pounds. The undamaged tractor was released to its driver at the scene before Safety Board investigators arrived, and drivers 1 and 2 returned to Tennessee in it. Therefore, no pre- or postcollision vehicle information is available on the tractor. Thirty-four inches of contact damage began on the left rear and extended toward the center of the semitrailer. The rear axles were displaced sideways to the left, and 17 feet of metal siding was displaced on the left side. (See photograph 1 in appendix B.) A visual examination of the semitrailer brakes showed that no parts were broken, missing, or excessively worn. No grease contamination was present, the drums were free from irregularities, and the brake linings met minimum required thickness standards. The trailer was equipped with automatic slack adjusters.

Photograph 1. -- Combination 1 trailer (view from rear toward front).

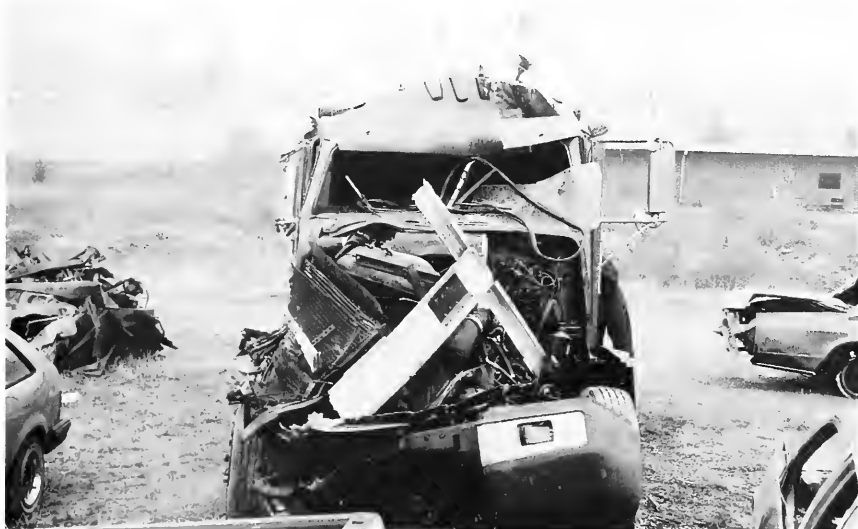
Vehicle 2 -- Vehicle 2 was a 1992 Freightliner tractor in combination with a 1987 Barrett, 48-foot split level livestock semitrailer that was loaded with cattle. The combination weighed 78,100 pounds. Thirty-one inches of contact damage was on the tractor front bumper, grill, and fenders, extending from the right side toward the center. The front structure was shifted 11 inches to the right, and the right side wheelbase was reduced 18 inches. The front structure of the semitrailer had substantial damage. (See photographs 2 and 3 in appendix B.)

Photograph 2. -- Combination 2 tractor.

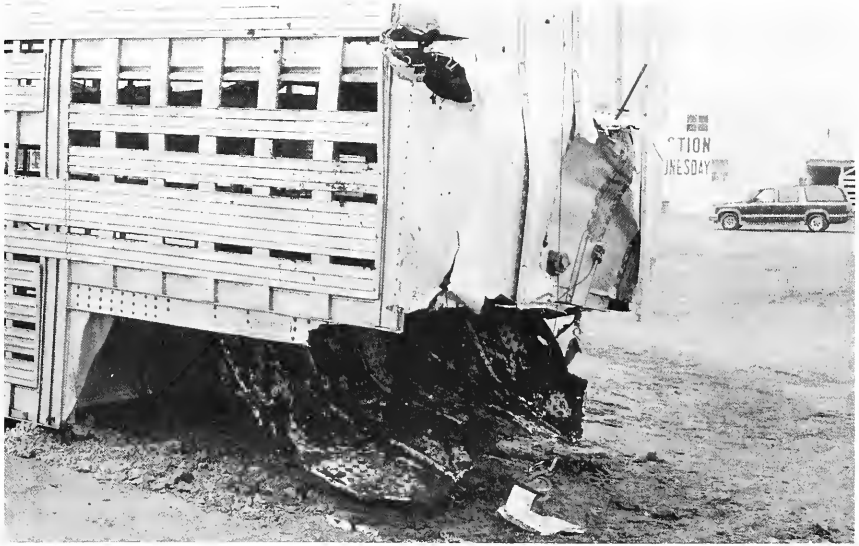
Photograph 3. -- Combination 2 trailer (front damage).

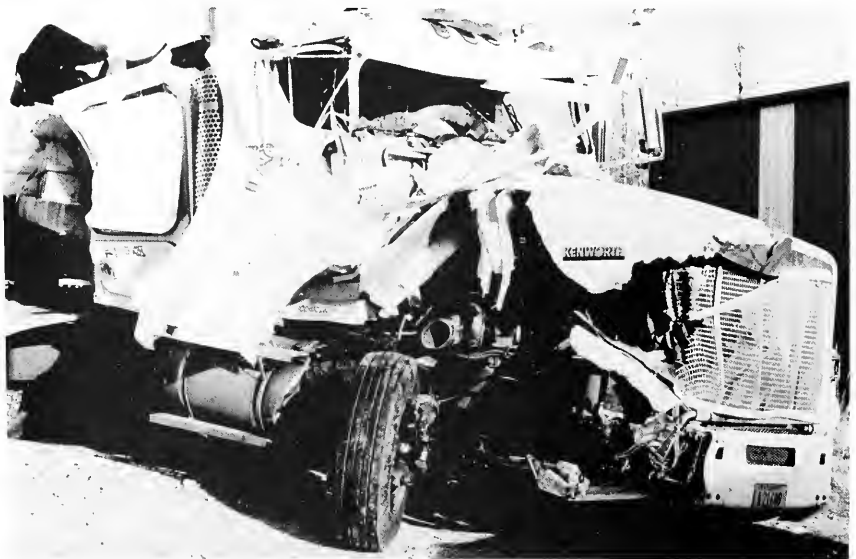
Vehicle 3 -- Vehicle 3 was a 1995 Kenworth truck tractor in combination with a 1990 Fruehauf, 48-foot flatbed semitrailer that was loaded with railroad ties. The estimated weight of the combination was 79,000 pounds. The right front of the tractor had 34 inches of contact damage, beginning at the right edge and extending in toward the center. The right front wheel was turned outward 75 degrees; the right front airbrake hose was separated from its frame connection. The forward headwall of the right side fuel tank was punctured, allowing fuel to leak out. The rear of the semitrailer had 48 inches of moderate contact damage that extended from the left side toward the center. The cargo of wood ties moved forward 90 inches at impact, and the shifting cargo pushed down and fractured the front headerboard.⁴ The rear of the sleeper cab was pushed inward approximately 24 inches. (See photographs 4, 5, and 6 in appendix B.)

Photograph 4. -- Combination 3 tractor.

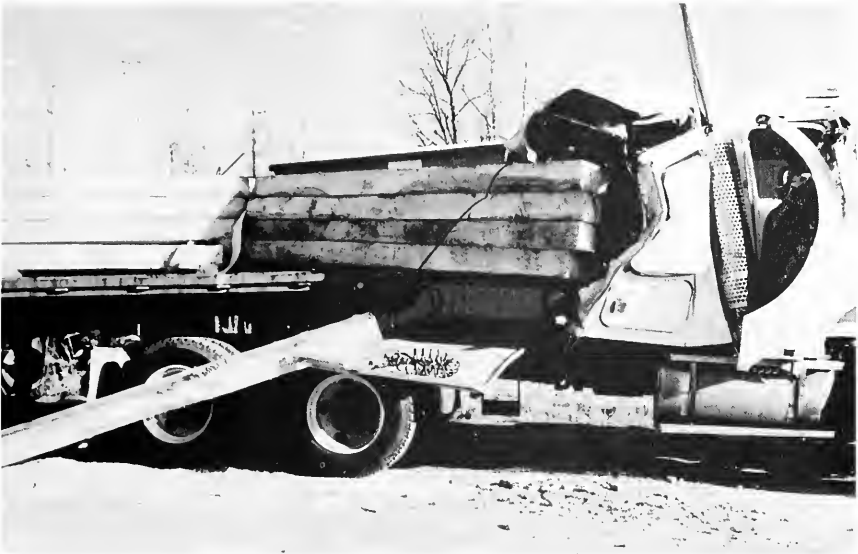
Photograph 5. -- Combination 3 (right side and rear tractor cab damage with headerboard deformation).

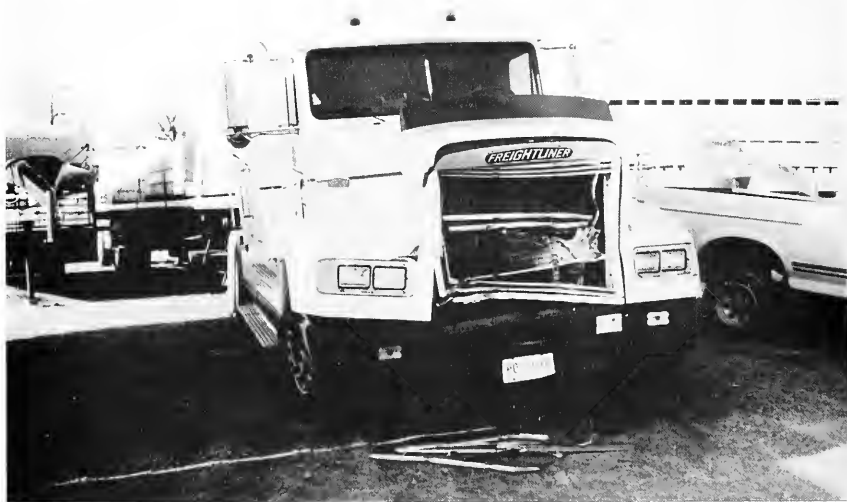
Vehicle 4 -- Vehicle 4 was a 1992 Freightliner tractor in combination with a 1994 Utility, 48-foot flatbed semitrailer loaded with wood railroad ties. The estimated weight of the combination was 80,000 pounds. The front of the tractor had radiator damage, and the semitrailer had 38 inches of contact damage on the left rear, extending from the left edge toward the center. Also, the headerboard on the front of the semitrailer was fractured similarly to the vehicle 3 semitrailer when its load shifted forward at impact. (See photographs 7 and 8 in appendix B.)

Photograph 7. -- Tractor 4.

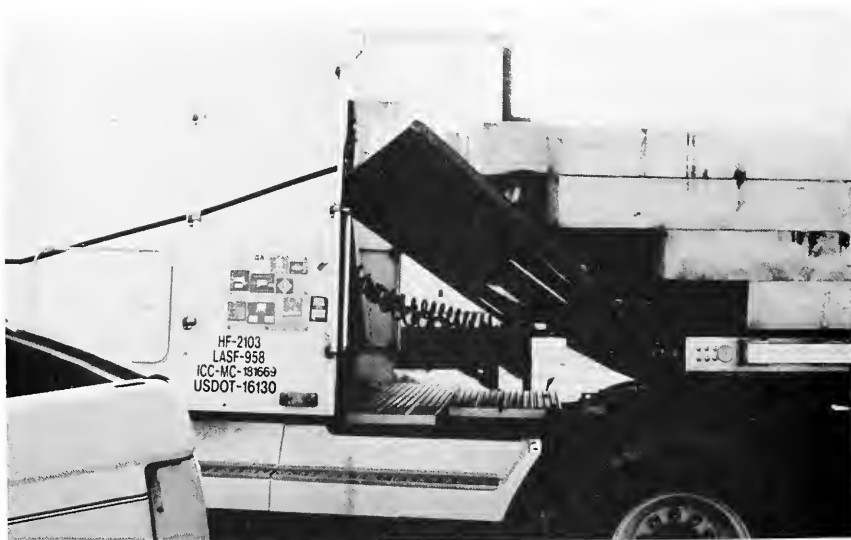
Photograph 8. -- Combination 4 (left side tractor/trailer with headerboard deformation).

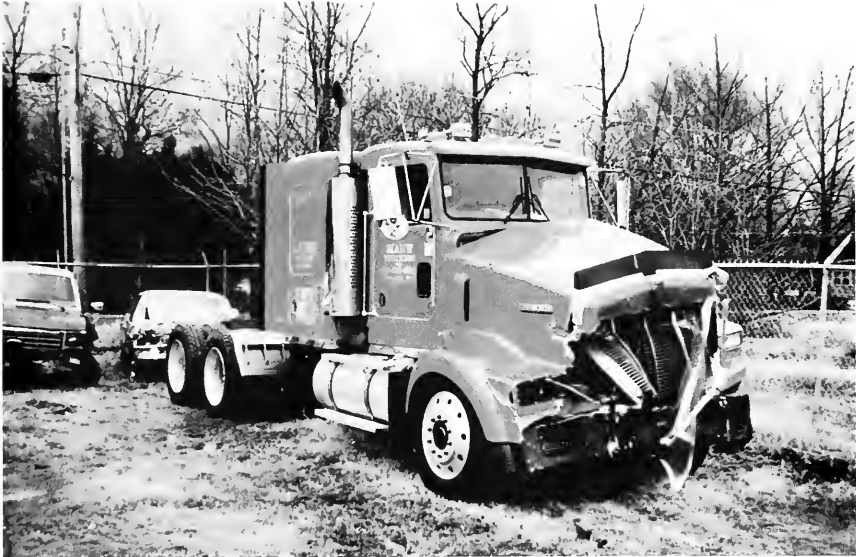
Vehicle 5 -- Vehicle 5 was a 1995 Kenworth truck tractor in combination with a 1984 Utility, 45-foot semitrailer loaded with scrap metal. The combination weighed 78,460 pounds. The tractor sustained substantial damage on its front, and the semitrailer had extensive rear impact and fire damage. The steel bed was pushed inward 11 inches, and the axles were destroyed by the postcrash fire. (See photographs 9 and 10 in appendix B.)

Photograph 9. -- Combination 5 tractor.

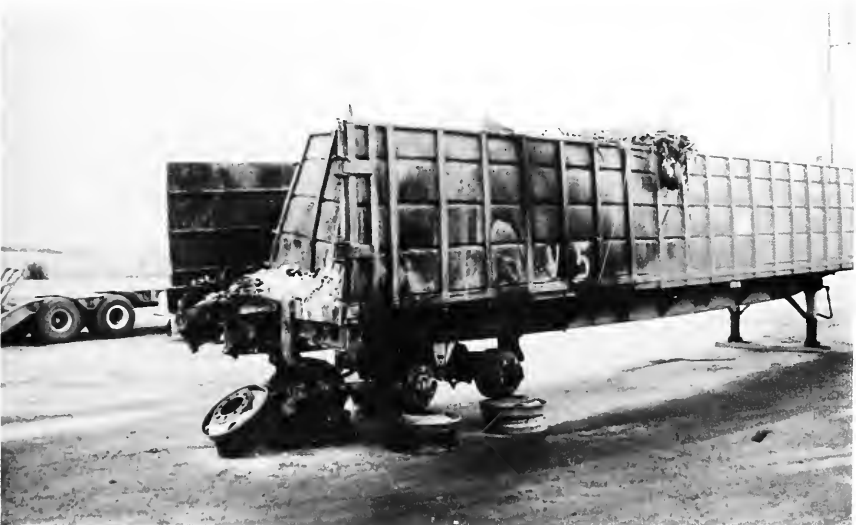
Photograph 10. -- Combination 5 trailer (rear impact and fire damage).

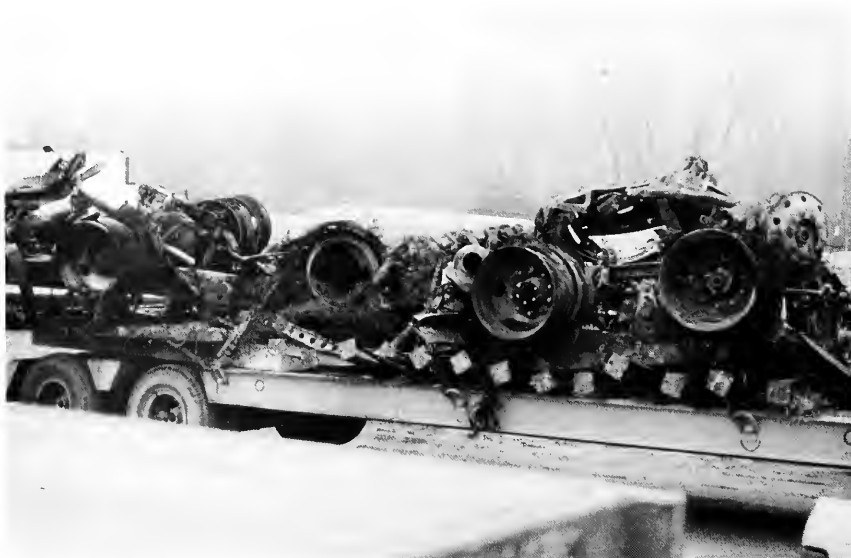
Photograph 11. -- Combination 6.

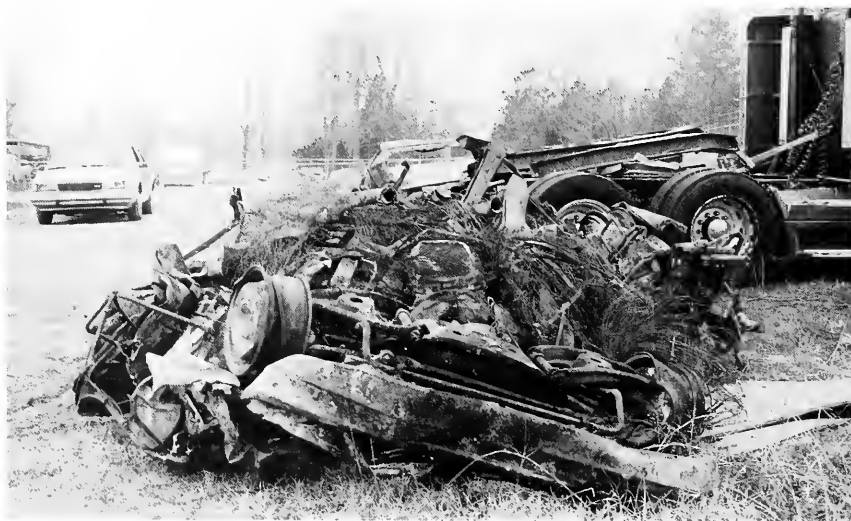
Photograph 12. -- Vehicle 7 (crushed van remains).

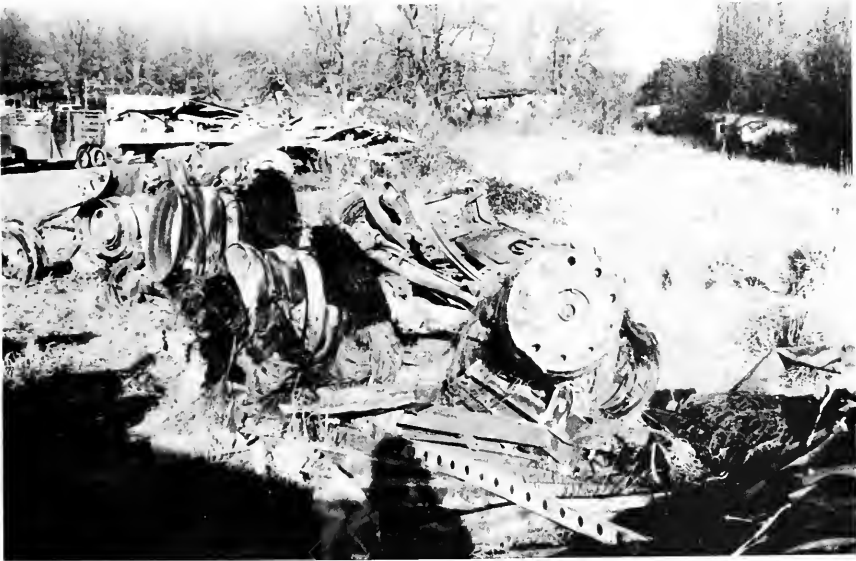
Photograph 13. -- Combinations 8 and 9 (remains).

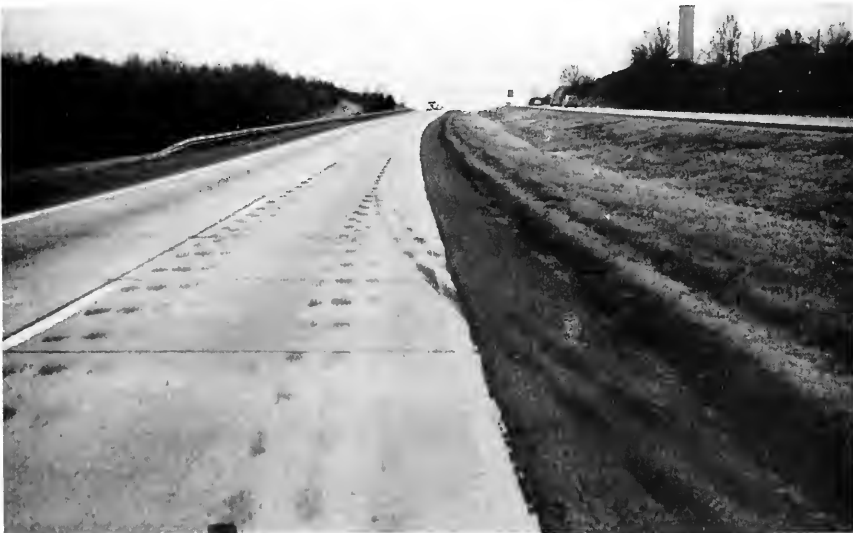
Photograph 14. -- Downgrade approaching accident site
(viewing back towards east).

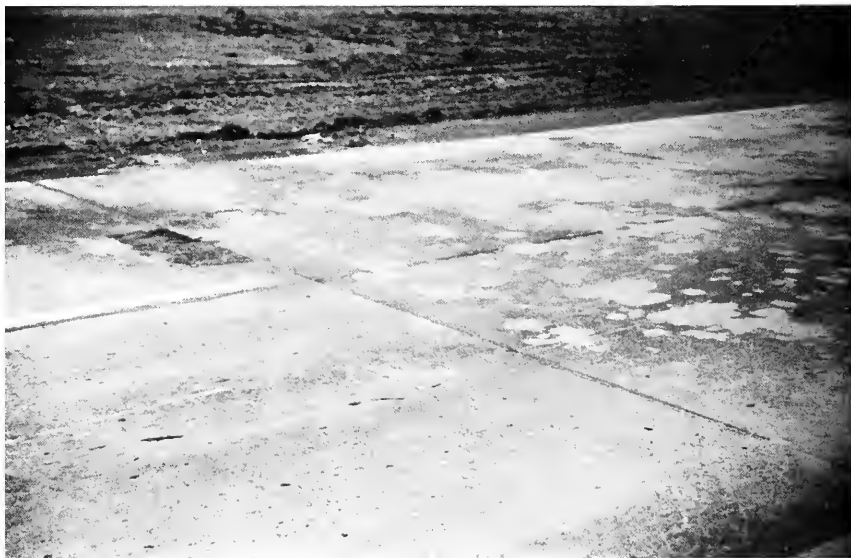
Postaccident Physical Evidence -- As a result of the collisions, the road surface was covered with fuel and debris. A large portion of the road surface, approximately 20 feet by 40 feet, was burned and scorched. (See photographs 15 and 16 in appendix B.) A significant amount of physical

Photograph 15. -- Accident site (road surface damage).

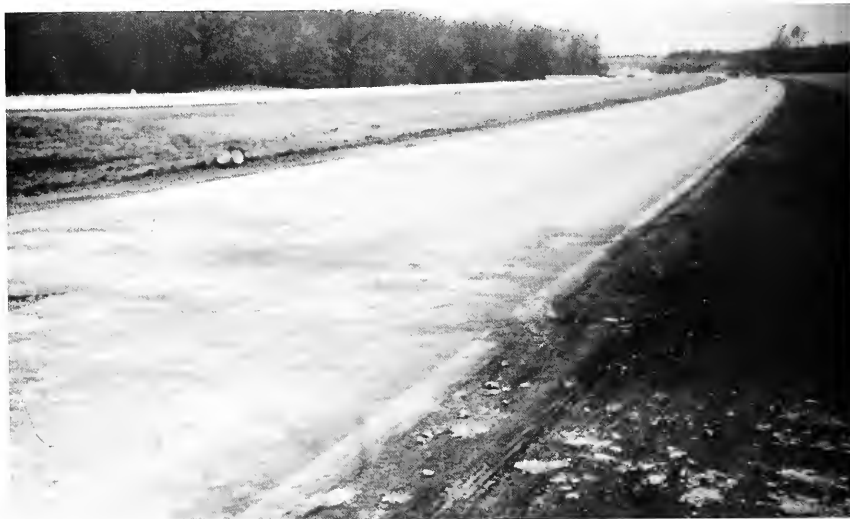
Photograph 16. -- Accident site (viewing toward west).
